LASER INDUCED DAMAGE TO NONLINEAR OPTICAL MATERIALS

C.R. GIULIANO AND D.Y. TSENG

HUGHES RESEARCH LABORATORIES

FINAL REPORT 1 JUNE - 1971 - 1 JUNE 1972 SEPTEMBER 1972

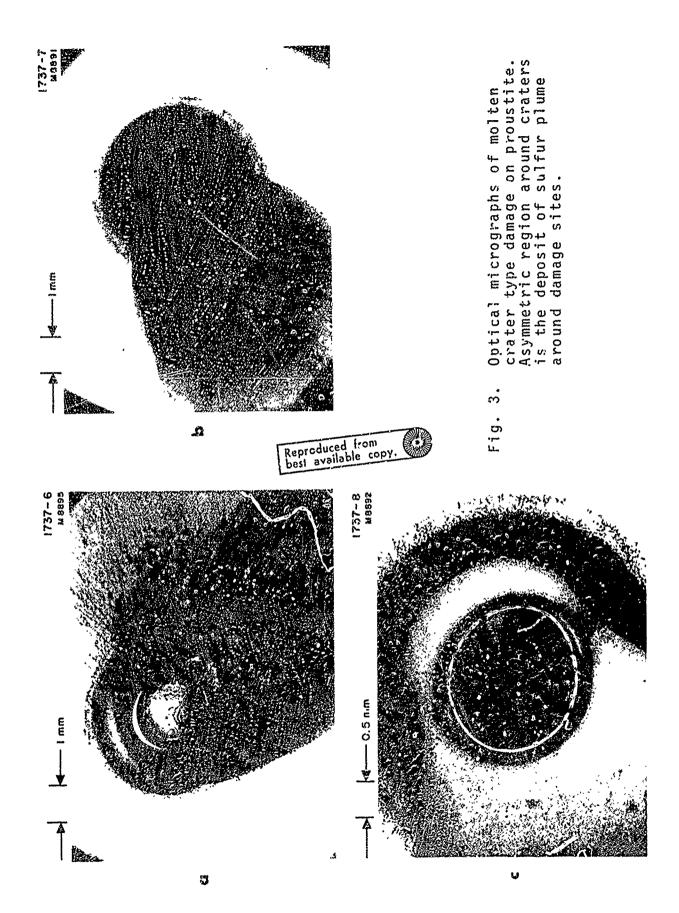
These have been seen to occur only during cw illumination at relatively high cw powers or when a previously created pulse damage site (see below) is illuminated with a relatively low cw power. The formation of these craters is accompanied by a plume of yellow smoke (presumably sulfur), which sometimes settles on the undamaged surface in the vicinity of the crater depending on the direction of air currents in the laboratory. The craters have slightly raised rims and very flat shiny bottoms that appear black in color and are apparently the results of molten puddles of decomposed material. Crater depth is typically 25 µm. This type of damage is the most catastrophic of the three types observed. Examples of this type of damage are seen in Fig. 3.

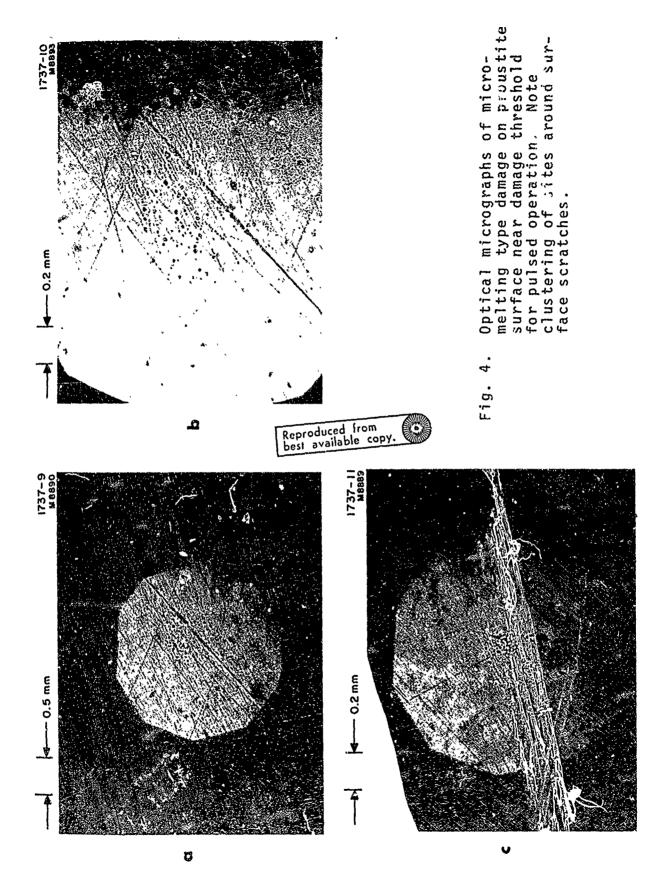
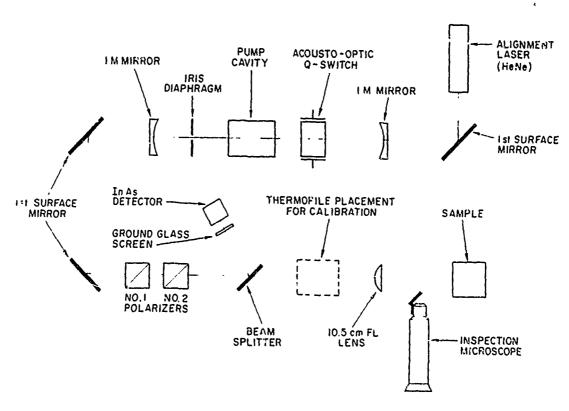
This type of damage occurs with either single pulsed or repetitively pulsed illumination. It is characterized by a series of somewhat randomly spaced tiny molten regions. The number and density of these regions depends both on the local surface finish and the incident power. When the power is appreciably above threshold, the molten regions merge to form a large variegated damage spot. At lower powers there is a tendency for these small globular sites to

cluster along lines of surface scratches. When observed through the low power microscope in the laboratory damage threshold setup, they appear to have a metallic luster and the region in which they are clustered has a darker color than the surrounding undamaged surface. Examples of this type of damage are seen in Figs. 4 and 5.

became visible in about a minute and when left under the microscope light, more sites appeared with time. An example of this is seen in Fig. 5(b) and (c). The region outside of the well-defined circular boundary contains a number of scattered sites that appeared after the sample had been subjected to microscope illumination for some time (~30 min). These should be contrasted with Fig. 5(a), which shows a relatively clear area outside of the circular laser-damaged region. This phenomenon, which was not investigated in detail, is another example of the peculiar nature of proustite damage. It only is seen to occur on previously damaged regions and may be the result of some ejection of decomposed matter from the initial damage sites. With the present limited knowledge of this proustite behavior, its origin can only be conjectured.
